Serious Event – Hydraulic Cylinder Failure

Safety Alert

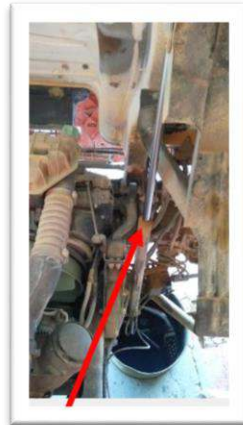
Hydraulic cylinder in situ

Hydraulic cylinder broke at this point

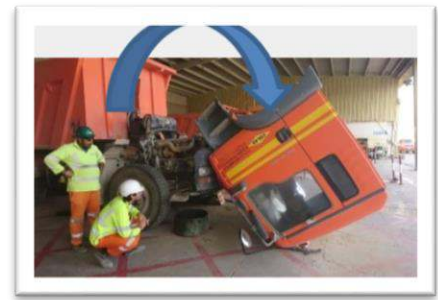
Broken piston rod end

Immediate Cause: The piston rod came away from the cylinder due the attaching threaded bolt failing.

Over 12 months ago, the original MAN cylinder was broken and could not be repaired, MAN manufacture the cylinder not to be repairable, in that damaged parts cannot be replaced. A local metal grinding workshop was therefore tasked with the manufacturing (threading) of a retaining bolt, by cutting/grinding a hole in the head of the rod and fitting a new seal on 24.05.17. The cylinder was kept in the store for nearly 12 months until required. The cylinder was then fitted on the truck the same day the incident occurred, so failed on first use.

Conclusion: The retaining bolt failed as it was under designed for the purpose, being too small a diameter, poorly fitted or was not a proprietary/branded part for the MAN cylinder. An inspection and report are awaited by an official MAN supplier.

- Check all hydraulic cylinders used for this purpose (tilting) on all vehicle cabs, that they are intact and have not been repaired in a similar manner.
- If a proprietary part cannot be sourced the whole unit should be replaced on such critical items.
- Review RA & SSOW to ensure there is no one standing near the cab during the tilting operation in case of repeat. Cones and tape can be deployed as barriers as part of the SSOW.
- Investigate secondary means of securing the cab once fully tilted.
