## Reinstatement of Rosenstrasse in Ochtrup, Germany - HaTelit® proves a long-term success -

Project/location: Ochtrup, Rosenstrasse, Germany

Client: Municipality of Steinfurt

Constructed: May 1996

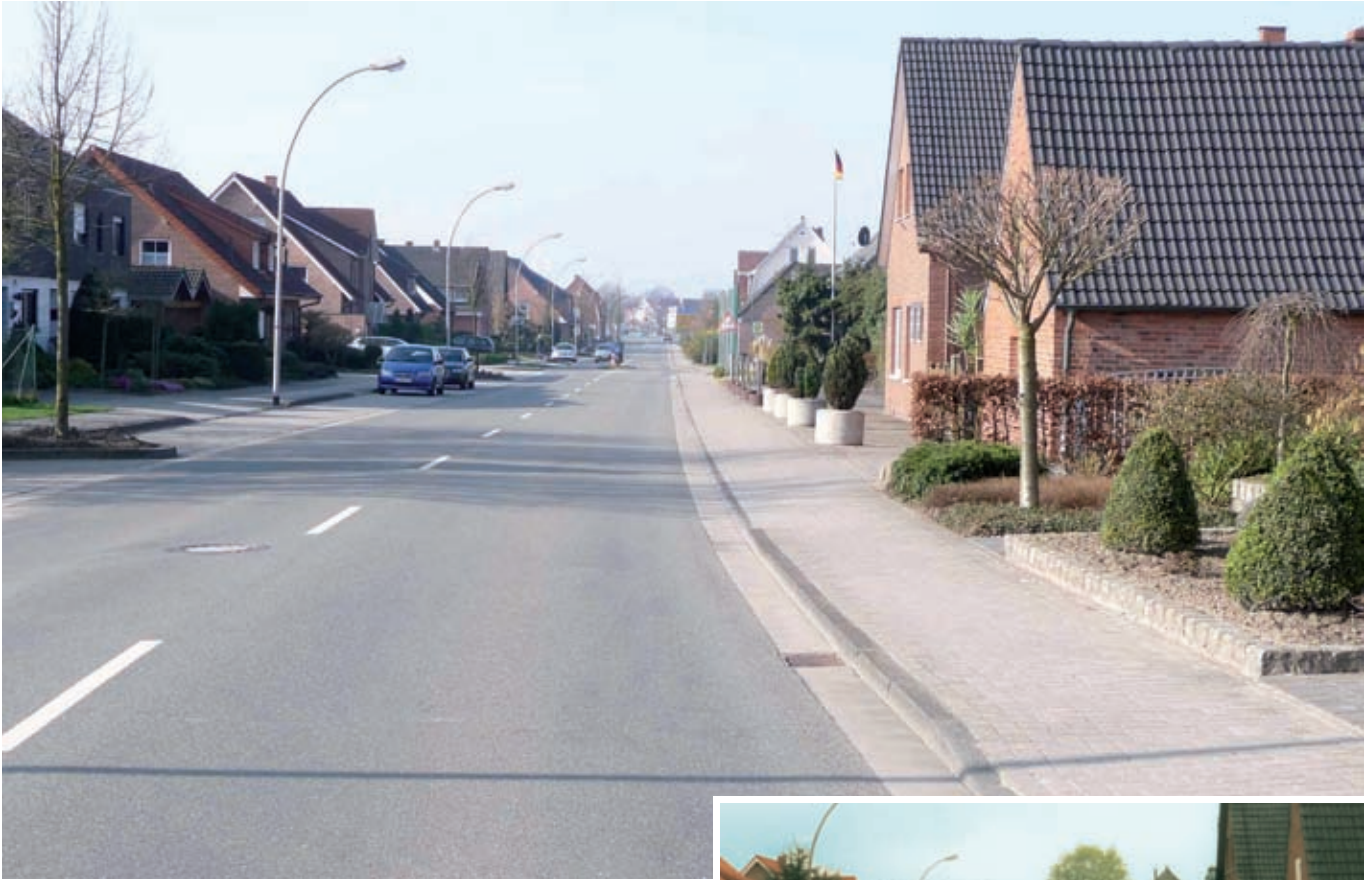
*Condition of Rosenstrasse in April 2009*

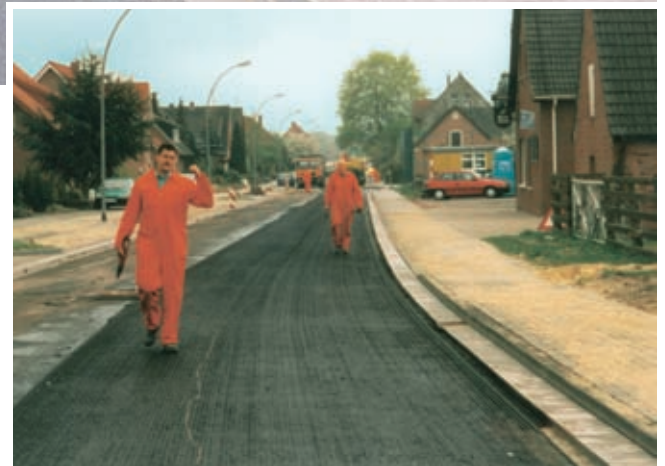
During the works **HaTelit®** was laid in accordance with the **HaTelit®** installation instructions and then covered with 5 cm asphalt-concrete 0/11 surface course.

For reasons of finance and time constraints, it was decided to install **HaTelit®** asphalt reinforcement directly on the milled substrate. This measure was intended to prevent early penetration of the existing cracks through the new surface course and therefore extend the period to the next reinstatement.

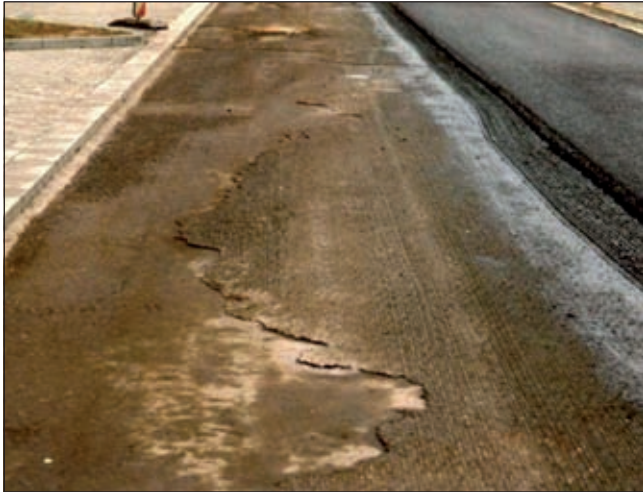
In 1996 Rosenstrasse was reinstated over its full carriageway width to rectify substantial damage due to alligator cracking. The initial design called for the existing 5 cm thick asphalt surface course to be milled off and replaced. After milling off the surface course, it was apparent that the binder course and even the base were also severely cracked and in very poor condition. An alternative design was required.

Condition of Rosenstrasse before overlay, May 1996

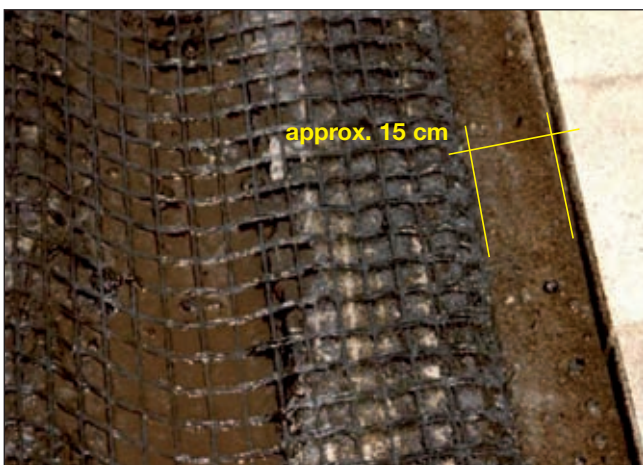
A small amount of transverse cracking was present at one location on the outer edge of the carriageway reinforcement. Small longitudinal cracks were evident at a few other spots which were also on the outer edge. Records of the installation show that no reinforcement is present in the outer edge areas. TÜV Rheinland confirms: "The whole of the rest of the carriageway is free of cracks."

Detail: Distance of reinforcement from the edge
