Reinstatement of Rosenstrasse in Ochtrup, Germany - HaTelit® proves a long-term success -

Project/location: Ochtrup, Rosenstrasse, Germany

Client: Municipality of Steinfurt

Constructed: May 1996

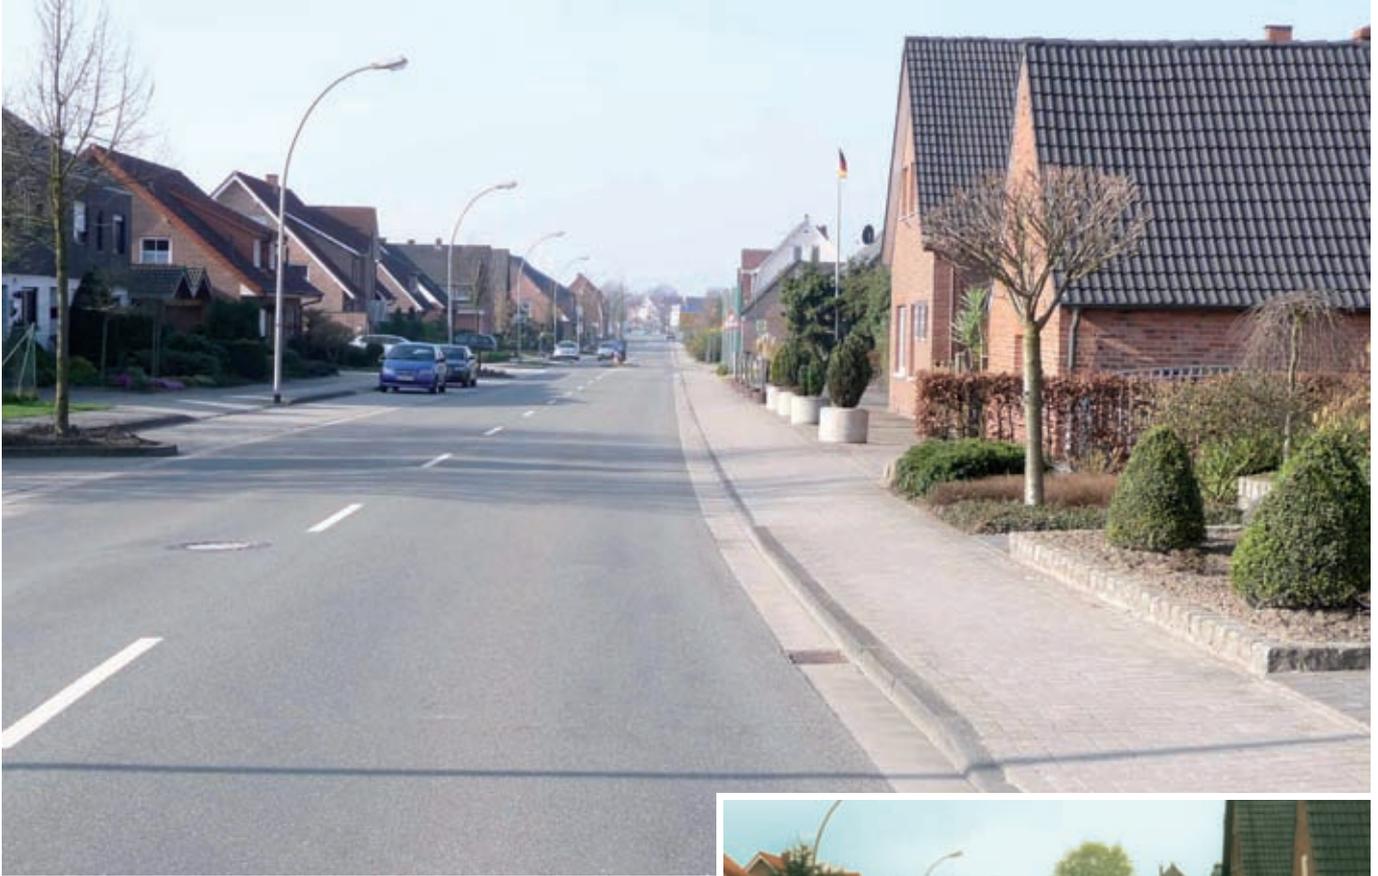
Condition of Rosenstrasse in April 2009

TÜV Rheinland LGA Bautechnik GmbH, Weimar Office has inspected and assessed the condition of the carriageway along the length of Rosenstrasse reinstated in 1996 with respect to crack formation. The visual inspection of the carriageway surface found it to be almost free of damage.

The road has remained in perfect condition and further reinstatement has not been necessary. The use of HaTelit® has proved itself a success as a method of reinstatement in every respect.

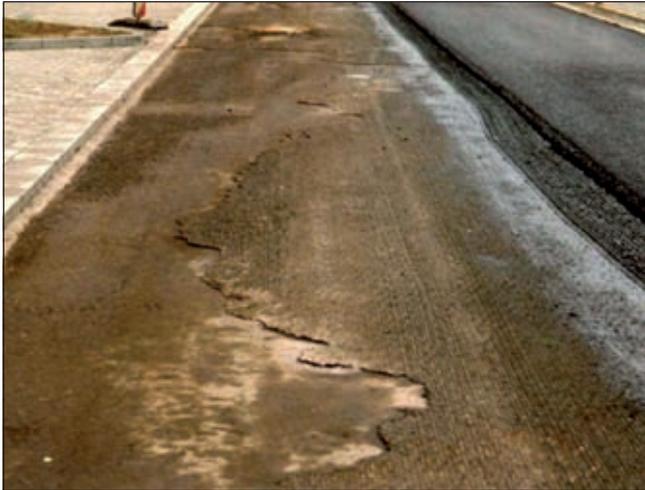
In 1996 Rosenstrasse was reinstated over its full carriageway width to rectify substantial damage due to alligator cracking. The initial design called for the existing 5 cm thick asphalt surface course to be milled off and replaced. After milling off the surface course, it was apparent that the binder course and even the base were also severely cracked and in very poor condition. An alternative design was required.

Condition of Rosenstrasse before overlay, May 1996

For reasons of finance and time constraints, it was decided to install **HaTelit®** asphalt reinforcement directly on the milled substrate. This measure was intended to prevent early penetration of the existing cracks through the new surface course and therefore extend the period to the next reinstatement.

During the works **HaTelit®** was laid in accordance with the **HaTelit®** installation instructions and then covered with 5 cm asphalt-concrete 0/11 surface course.

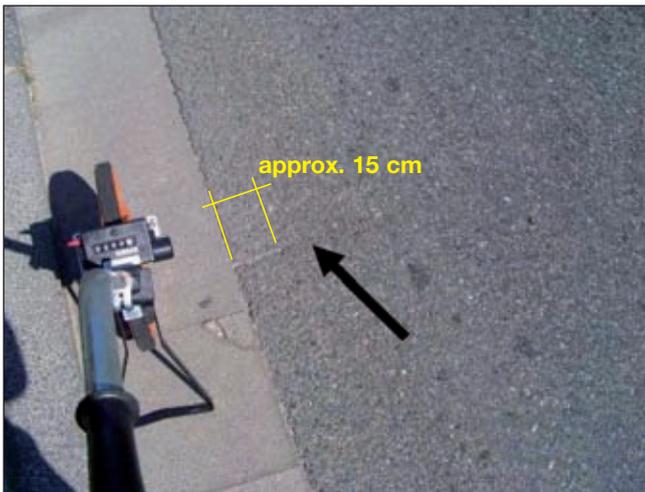
A small amount of transverse cracking was present at one location on the outer edge of the carriageway reinforcement. Small longitudinal cracks were evident at a few other spots which were also on the outer edge. Records of the installation show that no reinforcement is present in the outer edge areas. TÜV Rheinland confirms: "The whole of the rest of the carriageway is free of cracks."

Cracks found in edge area, August 2009
