## PRESERVATION CASE HISTORY

### A421 BUCKINGHAM BYPASS

<b>DATE OF COMPLETED APPLICATION</b>	October 1997
<b>SECTOR</b>	Single carriageway high-speed by-pass
<b>PAVEMENT SURFACE</b>	30/14 HRA surfacing course with 20mm PCC

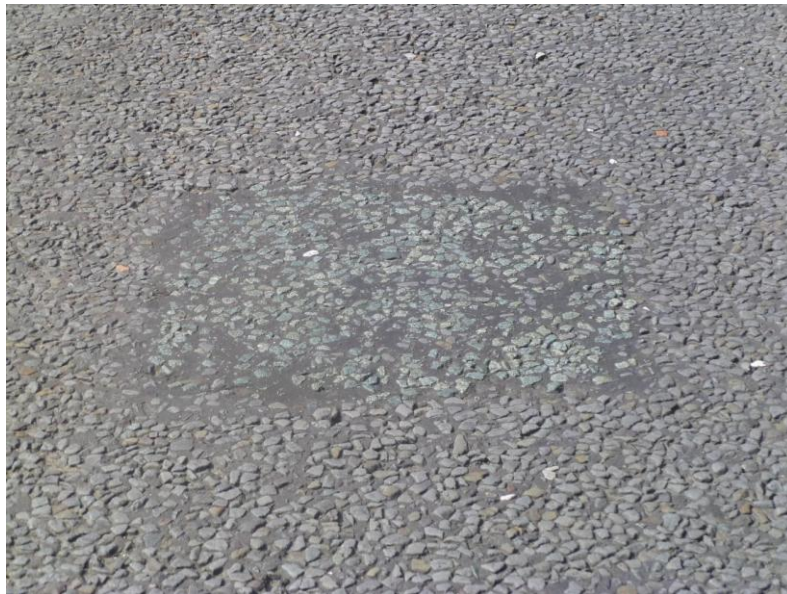
2011 – Showing repair in carriageway after 14 years

OUTCOME
<b>REPORT CONCLUSIONS</b>	<ol style="list-style-type: none"> <li>1. During the course of annual inspections over a number of years it has been noted that the surrounding road surface has gradually deteriorated in terms of chip loss and fines retention. This is in line with the expectations of a 15 year old HRA surface where the 50pen binder will have hardened over time.</li> <li>2. This is not the case on the repaired area which shows full chipping retention and no loss of surface fines.</li> <li>3. This continues to be the case and for this reason the site was offered as evidence of the effectiveness of both Rhinopatch and Rhinophalt when going through HAPAS accreditation in 2004 and 2007 respectively.</li> <li>4. In the case of the Rhinopatch repair the area has remained in as built condition with no break up at the interfaces.</li> <li>5. As part of the Rhinopatch process, Rhinophalt is applied in order to preserve the repair. One of the primary claims of Rhinophalt is that it will prevent aggregate loss from a treated surfacing course as evidenced by the examples discussed in this document.</li> </ol>
