Bitumen Emulsion Spill

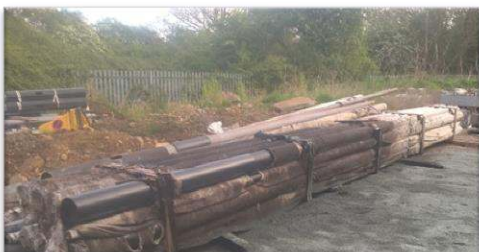
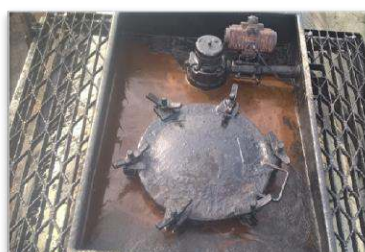
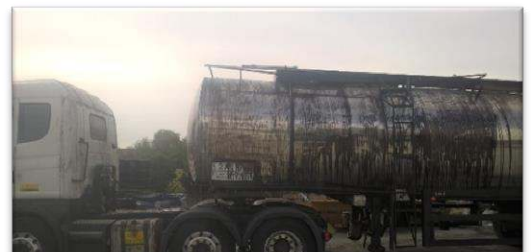
An incident occurred when a Bitumen Emulsion Tanker arrived to discharge into an Emulsion Tanker in a storage depot. Before the transfer process the operative connected the pipework to the delivery truck and opened the top hatch to inspect the contents. The process of transfer started and continued for 25 minutes, after which the pipework started to shake indicating the tank was also emptying. The operative instructed the delivery driver to wait until the top hatch was closed before the pipes were cleared.

The operative climbed on top of the tanker and instructed the delivery driver to cease transfer. During this process the hatch was not fully closed and the delivery driver failed to immediately switch off the transfer, reverting to the emergency shut off valve. Unfortunately, the tanker blew air through the lines and sprayed bitumen emulsion through the top hatch. As the operative tried to close the lid it created a spray off emulsion over the lower half of the operative, over the tanker and on the surrounding streetlighting columns. The operative was unharmed and the spillage was quickly dealt with in the depot.

This incident could have caused severe injuries to the driver and caused significant environmental damage.
