Crush Injury to Mechanics Hand Whilst Repairing a Hopper – Lost Time Injury

Safety Alert

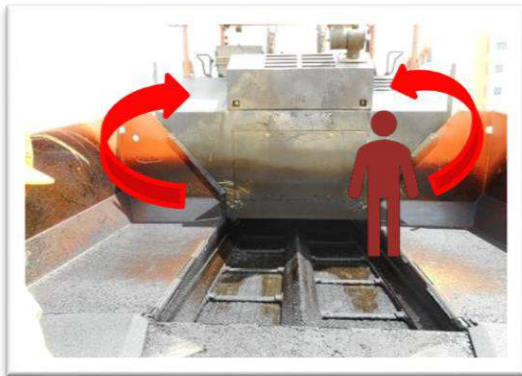
1. Hopper Wings Open

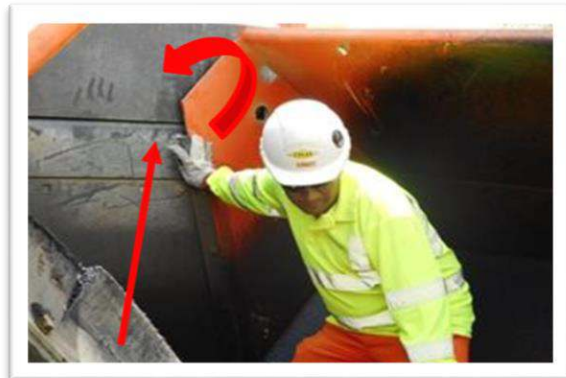
It was during this operation the IP's finger became trapped in between a 'stopper' and the paver wing as he had placed his right hand on the back of the hopper where the wing moves into the closed position. He sustained severe lacerations to his finger.

2. Finger crushed by hopper wing

Immediate Cause: Hopper wing closing on IP's finger.

Root Cause Analysis results: The IP and the chargehand were stood inside the hopper during operation, as they could not see from any other position if the hydraulic connections were still leaking following the maintenance works. They were also unfamiliar with this type of paver due to lack of awareness and felt they had to be inside the hopper to ensure its correct operation.

1. All personnel carrying out maintenance/repair work are to isolate and refrain from working on machinery which is operating.

2. All personnel must be aware of the particular hazards associated with each machine by being trained and fully briefed on them.
3. Follow the Golden Rules at all times
4. A Risk Assessment and SSOW for each machine is to be developed and briefed out to all associated personnel.
