Safety Alert

Broken Toe

Alert No 08/2018 Page 1 of 2

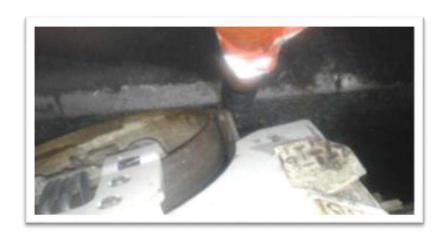
On 9th February 2018 at 2010, during refuelling operations, the rear drum of a roller met a surfacing operative's left foot resulting in a broken big toe.

- 1.Improper decision making or lack of judgement Roller driver moved before he was certain the IP was clear of the machine.
- 2.Lighting issues lighting to the area was good but once other plant had left the parking area, the section where the incident occurred was dark.

- The safe system of work that manages the people plant interface was not adopted. The IP was stood near plant which was prohibited under the SSOW.
- 4. Lack of spatial awareness The IP believed he was in s position of safety due to the fact he was stood on a raised verge. His foot was hanging over the verge / half battered kerbstone allowing contact with the rear drum of the roller.

- Ensure that plant operators and site personnel are aware of ALL safe systems of work for their tasks.
- When operating plant and equipment guards, ensure the safe system of work that has been identified sand is implemented fully at the work site.
- Ensure that the agreed controls are documented in the risk assessment for the activity sand that these controls are implemented every time the activity is undertaken.
- Ensure adequate supervision is present at site.
- Ensure correct training has been given to the personnel who carry pout the activity.
- Ensure that safe system of work is included in pre start site safety stand downs.
