Level Crossing Potential Incident

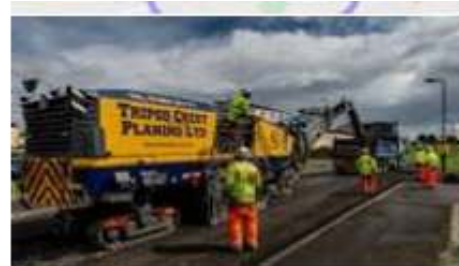
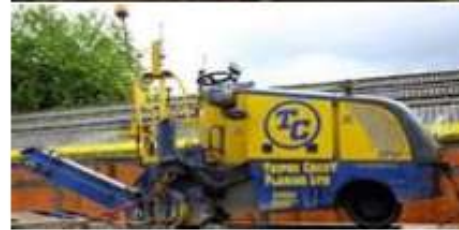
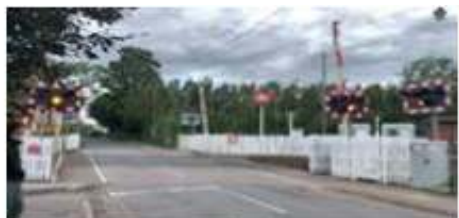
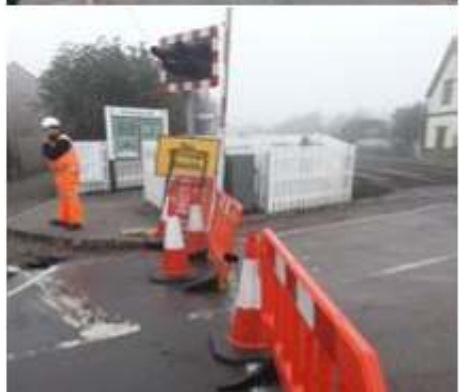
The level crossing barrier then began to close, due to an oncoming train, the barrier made contact with the rear of the planer. The planer continued to move forward and then the barrier fully closed but was damaged – this incident was reported to *Network Rail*, who attended site to investigate and inspect.

A full investigation has been carried out into the incident which highlighted serious gaps in the planning and management process, with key holding points not being adhered to. Any adjacent infrastructure works within 200m of live railways, must be notified by the asset owner, with the contractors RAMS, to Network Rail Asset Protection & Optimisation (ASPRO) team.
