# Safety alert

# Lorry fire – BPO Resin Hardener.

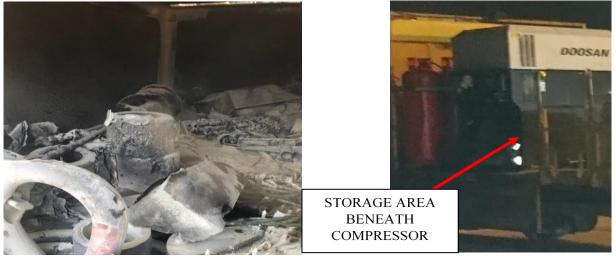
WHILST DRIVING TO SITE ON 23<sup>RD</sup> JUNE, THE DRIVER NOTICED SMOKE COMING FROM THE COMPRESSOR AREA. ONCE HE HAD PULLED OVER AND WENT TO THE SIDE OF THE COMPRESSOR UNIT, HE FOUND THE STORAGE UNIT BELOW TO BE ON FIRE. THE FIRE WAS QUICKLY PUT OUT USING THE 6KG FIRE EXTINGUISHER ON BOARD. NO LASTING DAMAGE WAS CAUSED AND THE DRIVER & PASSENGER WERE BOTH UNHARMED.

THE COMPRESSOR HAD NOT BEEN USED AND SO NO EXTERNAL SOURCES OF IGNITION / HEAT WERE PRESENT. HOWEVER, IT IS BELIEVED THAT A BAG OF BPO RESINHARDENER PRODUCT HAD BEEN LEFT BENEATH THE COMPRESSOR FROM PREVIOUS WORKS.

THE SAFETY DATA SHEET FOR THE BPO RESIN HARDENER PRODUCT STATES THAT THIS PRODUCT MUST BE STORED AWAY FROM HEAT, NAKED FLAMES AND ALSO IN COOL VENTILATED AREAS BETWEEN 5°C AND 25°C. THE OUTSIDE WEATHER TEMPERATURE ON THE AFTERNOON / EVENING WHEN THE DRIVER LEFT FOR SITE HAD REACHED APPROX. 30°C, MEANING THAT THE TEMPERATURE WITHIN THE METAL STORAGE AREA BENEATH THE COMPRESSOR COULD HAVE REACHED TEMPERATURES IN EXCESS OF 30°C, CAUSING THE BPO PRODUCT TO SLOWLY SELF COMBUST / CATCH FIRE.

WITH IMMEDIATE EFFECT, ALL COMBUSTIBLE / FLAMMABLE MATERIALS (INCLUDING BPO) ARE TO BE REMOVED FROM WORK VEHCILES AND STORED INSIDE DEPOTS BETWEEN SHIFTS. WHEN STORED ON VEHICLES, THEY ARE TO BE STORED AWAY FROM HEAT, SPARKS AND NAKED FLAMES IN WELL VENTIALTED AREAS. IN WEATHER OF EXTREME TEMPERATURES, COVER THE MATERIALS TO PROTECT FROM DIRECT SUNLIGHT.
