Temporary Works – Excavation Collapse

Incident Description

Safety Alert

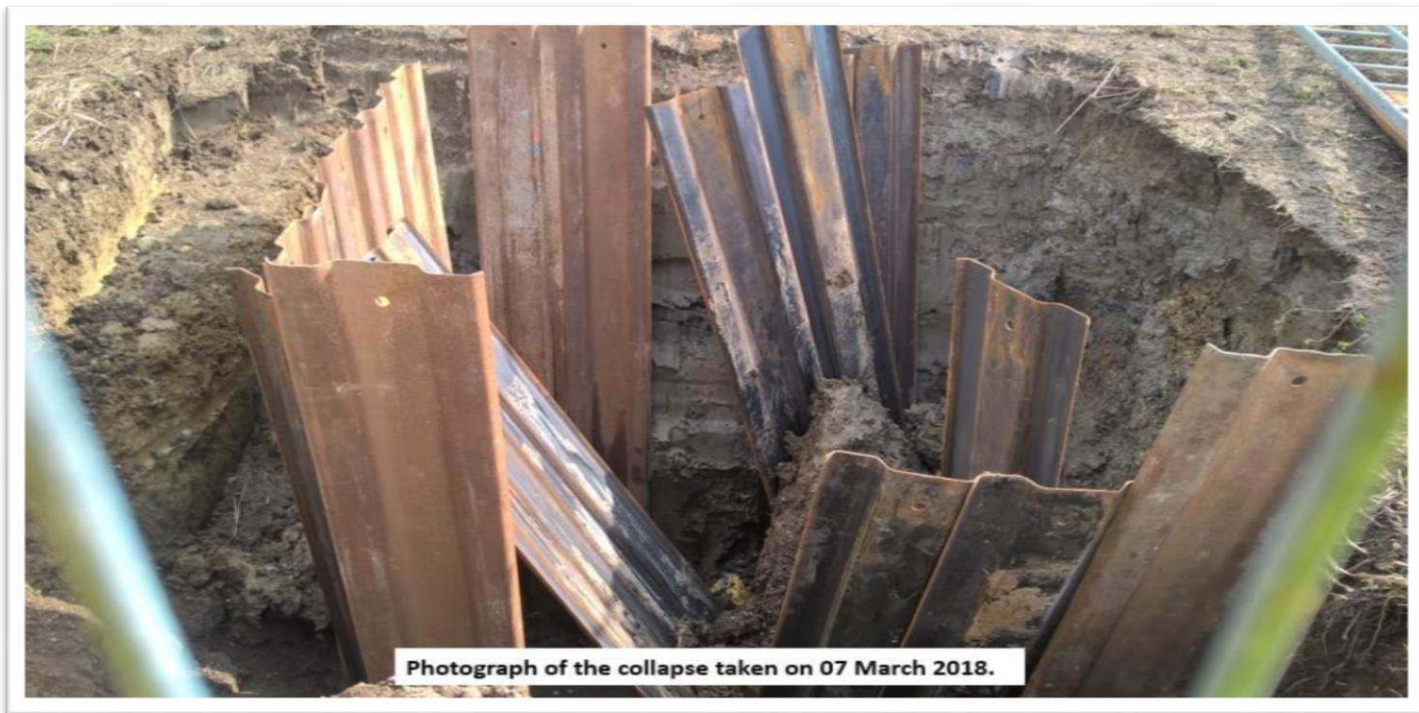
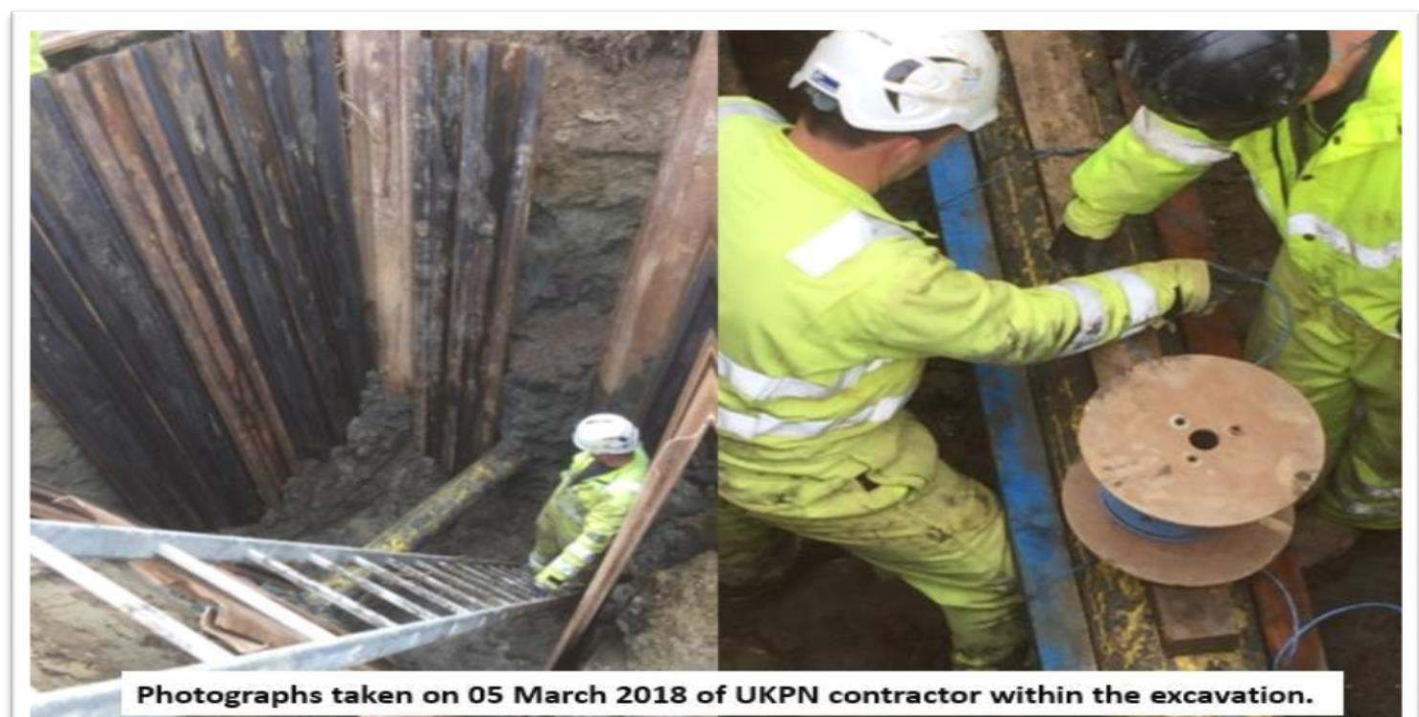
A near miss occurred on Wednesday 7th March 2018 when an open excavation collapsed on site at the A14 improvement project in Cambridgeshire. The works included the excavation of a trial hole to identify the position of existing gas services. A contributing factor was that the ground was also very wet following recent heavy snow/rain.

The excavation to expose the services had been completed and steel shuttering sheets were installed around the trial hole. This installation was incomplete and not in accordance with the temporary works design. No pre-access inspections had been carried out. An Investigation into this incident is now underway.

However, the photographs below demonstrate the potential severity of this type of incident.

- The temporary excavation supports were not installed as designed.
- Lack of inspection by a competent person prior to access/use.
- Lack of understanding/consideration of the potential impact that the poor weather conditions will have on an open excavation(s).

- Work was immediately suspended, and an exclusion zone set up around the incident area.
- An Industry Alert has been issued by UKPN.
- Investigations have commenced.

- Safety Stand Down and re start induction/ briefings have now been carried out.
- A full review of the Safe Systems of Work is being carried out.
- When temporary works are installed They shall be constructed in accordance with the agreed design and inspected on completion (and prior to use).

- An inspection by a competent person shall be completed and recorded at the start of each shift, and after any event that may have affected strength or stability, such as heavy rain or following prolonged dry periods or change in traffic management
